INGENIOUS INFILL

Before a deteriorating bridge from the 1930s could be removed in downtown St. Louis, project designers had to devise a way to fill in the 30 ft deep excavation beneath the ground-level structure without imposing lateral loads on adjacent buildings. The novel solution involved using blocks of lightweight expanded polystyrene near the buildings and traditional soil fill within the rest of the excavation.

By Justin Anderson, P.E., M.ASCE, Patrick Poepsel, P.E., M.ASCE, and Kevin Kriete, P.E., M.ASCE

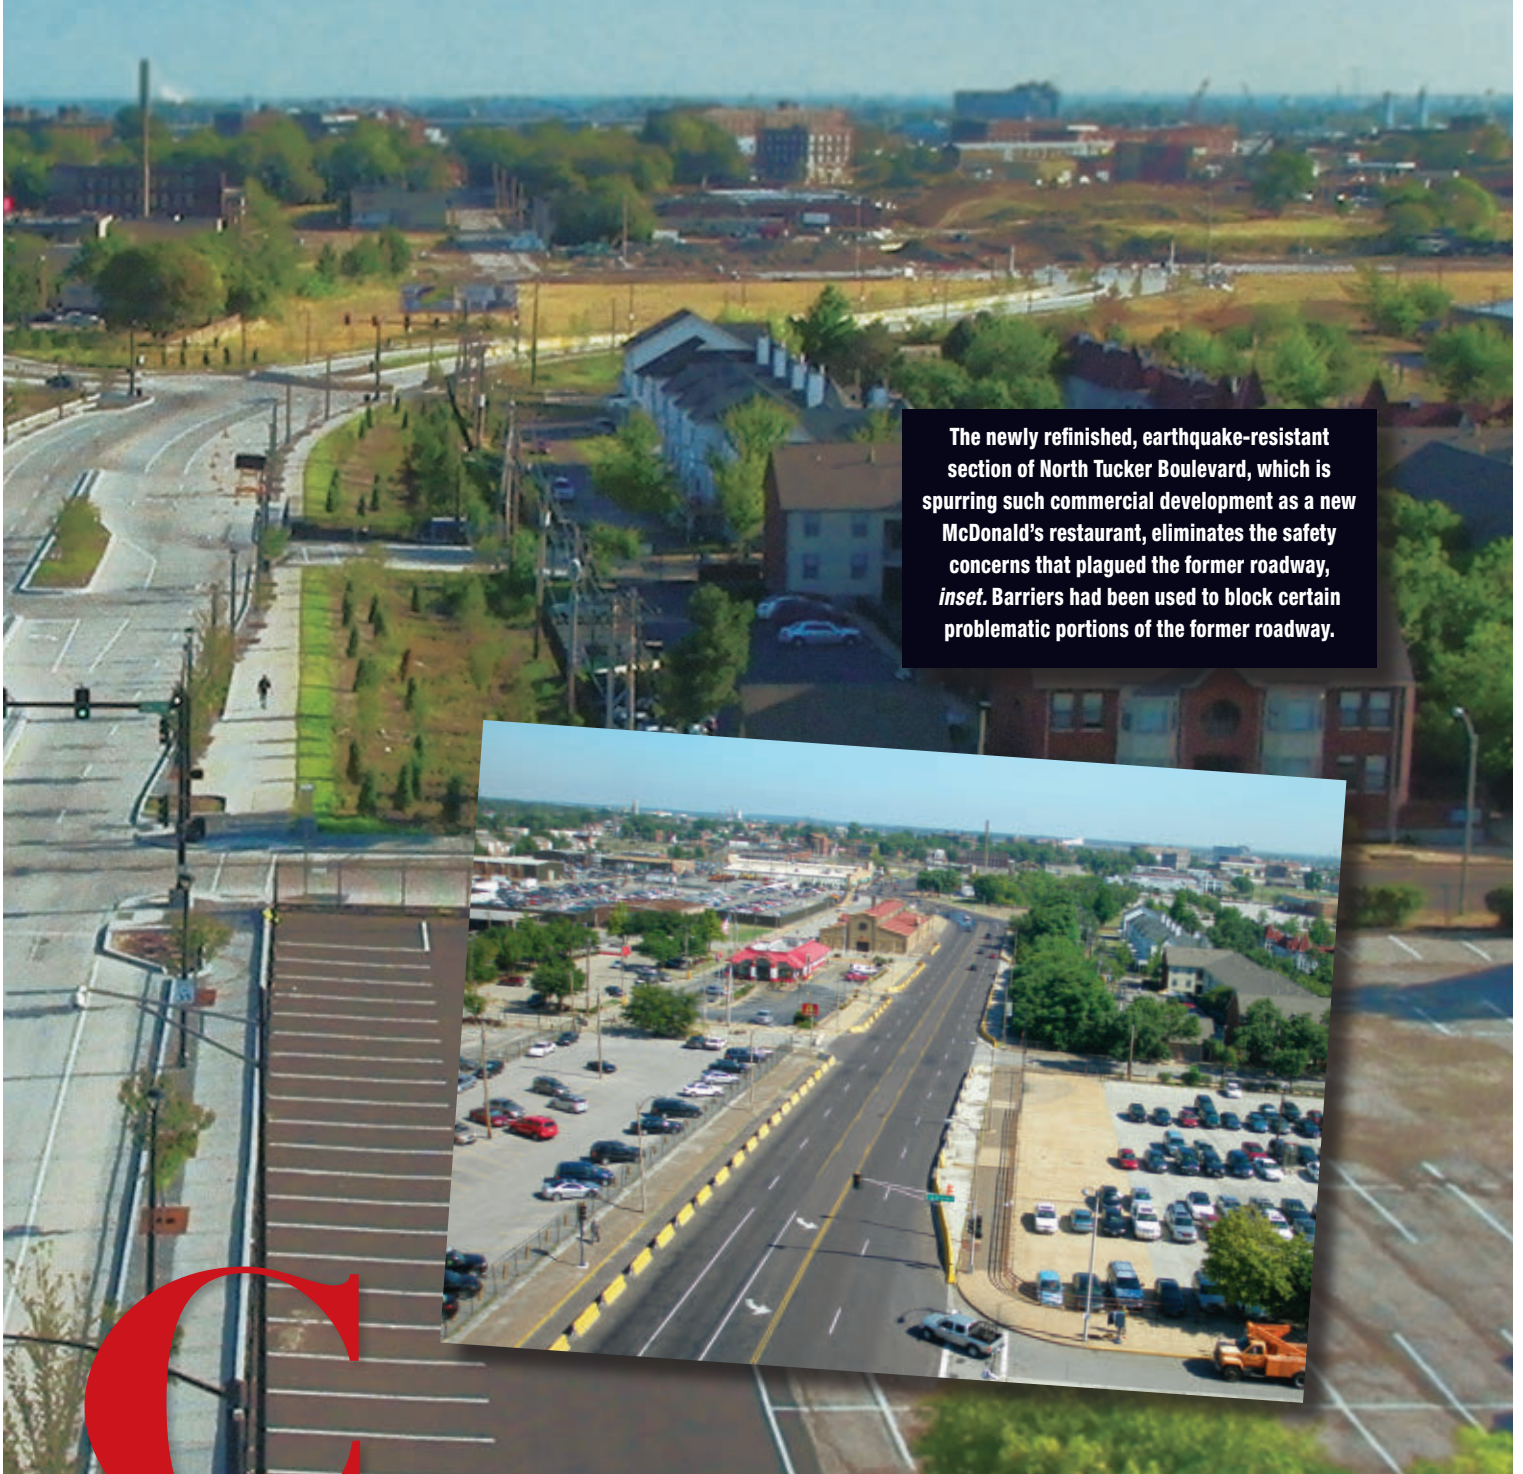
The newly finished, earthquake-resistant section of North Tucker Boulevard, which is spurring such commercial development as a new McDonald's restaurant, eliminates the safety concerns that plagued the former roadway, *inset*. Barriers had been used to block certain problematic portions of the former roadway.

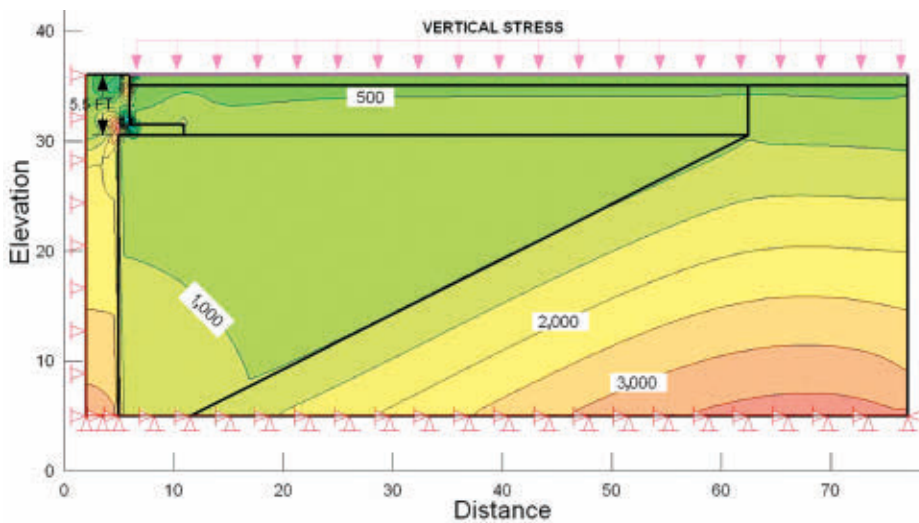
SAMPLE VERTICAL STRESS DISTRIBUTION THROUGH EPS AND CONVENTIONAL FILL AND LOAD TRANSFER TO EXISTING BUILDING

configuration when subjected to traffic and seismic loading. The program SIGMA/W—developed by GEO-SLOPE International Ltd., of Calgary, Alberta—was used to model the stress distribution and deformation of the EPS and to estimate the load transfer from the embankment to the building under traffic and seismic loadings. The design section consisted of a 6 ft thick soil planting layer, a 6 in. thick concrete load distribution slab, and about 25 ft of EPS fill extending down to native soils.

The SIGMA/W analyses were used to estimate the density of EPS fill required to resist the imposed stresses throughout various zones of the embankment. Finite-element analyses model linearly elastic properties, and because the linearly elastic properties of EPS, that is, the modulus of elasticity and the Poisson ratio, generally vary with density, several iterations were required to refine the model and converge on the required EPS density. Example output from the analysis showing the vertical stress distribution through the EPS and conventional fill, as well as the load transfer to an existing building, is shown in the figure above. Example output showing the estimated deformation of the EPS is shown in the figure at right. The visual representation of the deformation has been exaggerated by a factor of 100 to improve clarity. The maximum predicted vertical and horizontal deformations were estimated to total less than respectively 0.3 and 0.01 in. The results estimated minor, relatively uniform deformations within the EPS and across the soil section, indicating a low potential for dif-

ferential settlement and permanent deformation of the EPS and pavement section.

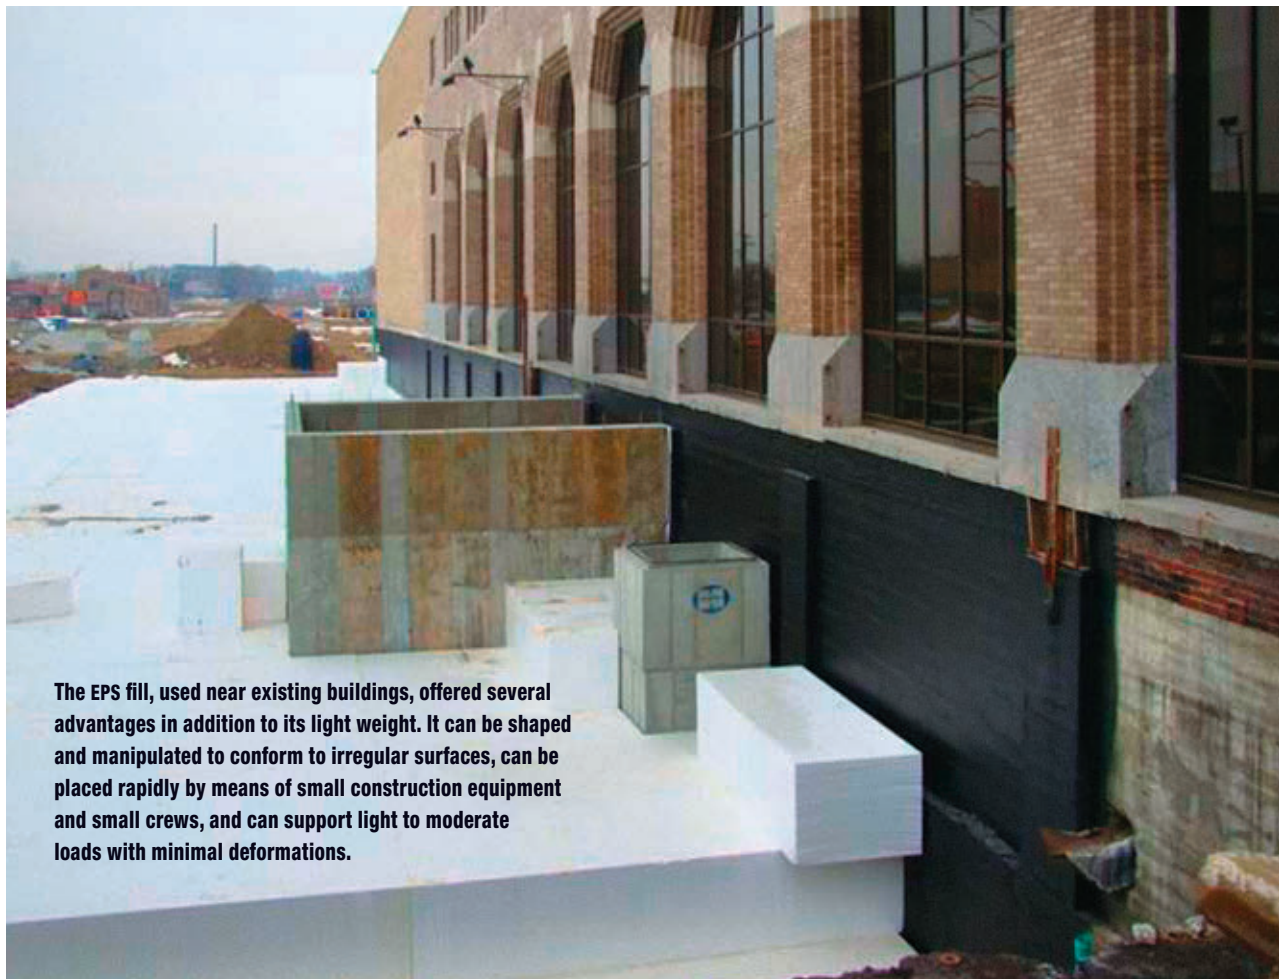
The EPS fill, used near existing buildings, offered several advantages in addition to its light weight. It can be shaped and manipulated to conform to irregular surfaces, can be placed rapidly by means of small construction equipment and small crews, and can support light to moderate loads with minimal deformations.

For its part, the EPS fill was found to offer several advantages. With its extremely light weight of 1 to 2 pcf, EPS is ideal for use in an embankment in which minimal consolidation settlement of existing soft clay foundation soils is desired. Easily shaped and manipulated to conform to irregular surfaces, EPS can be placed rapidly with the aid of small construction equipment or even by hand, requiring a crew of just two to four persons per block. Relatively strong and stiff, EPS can support light to moderate loading with minimal deformation and remain within the elastic range.
